Facility and Support Services

Subj: Repairs to the Courthouse roof

After we made recent repairs to the roof on the Court House, Craig Jones inspected the two smaller upper level roofs. We have included several digital photos to show the problems. The following items can cause leaks on these perimeter walls:

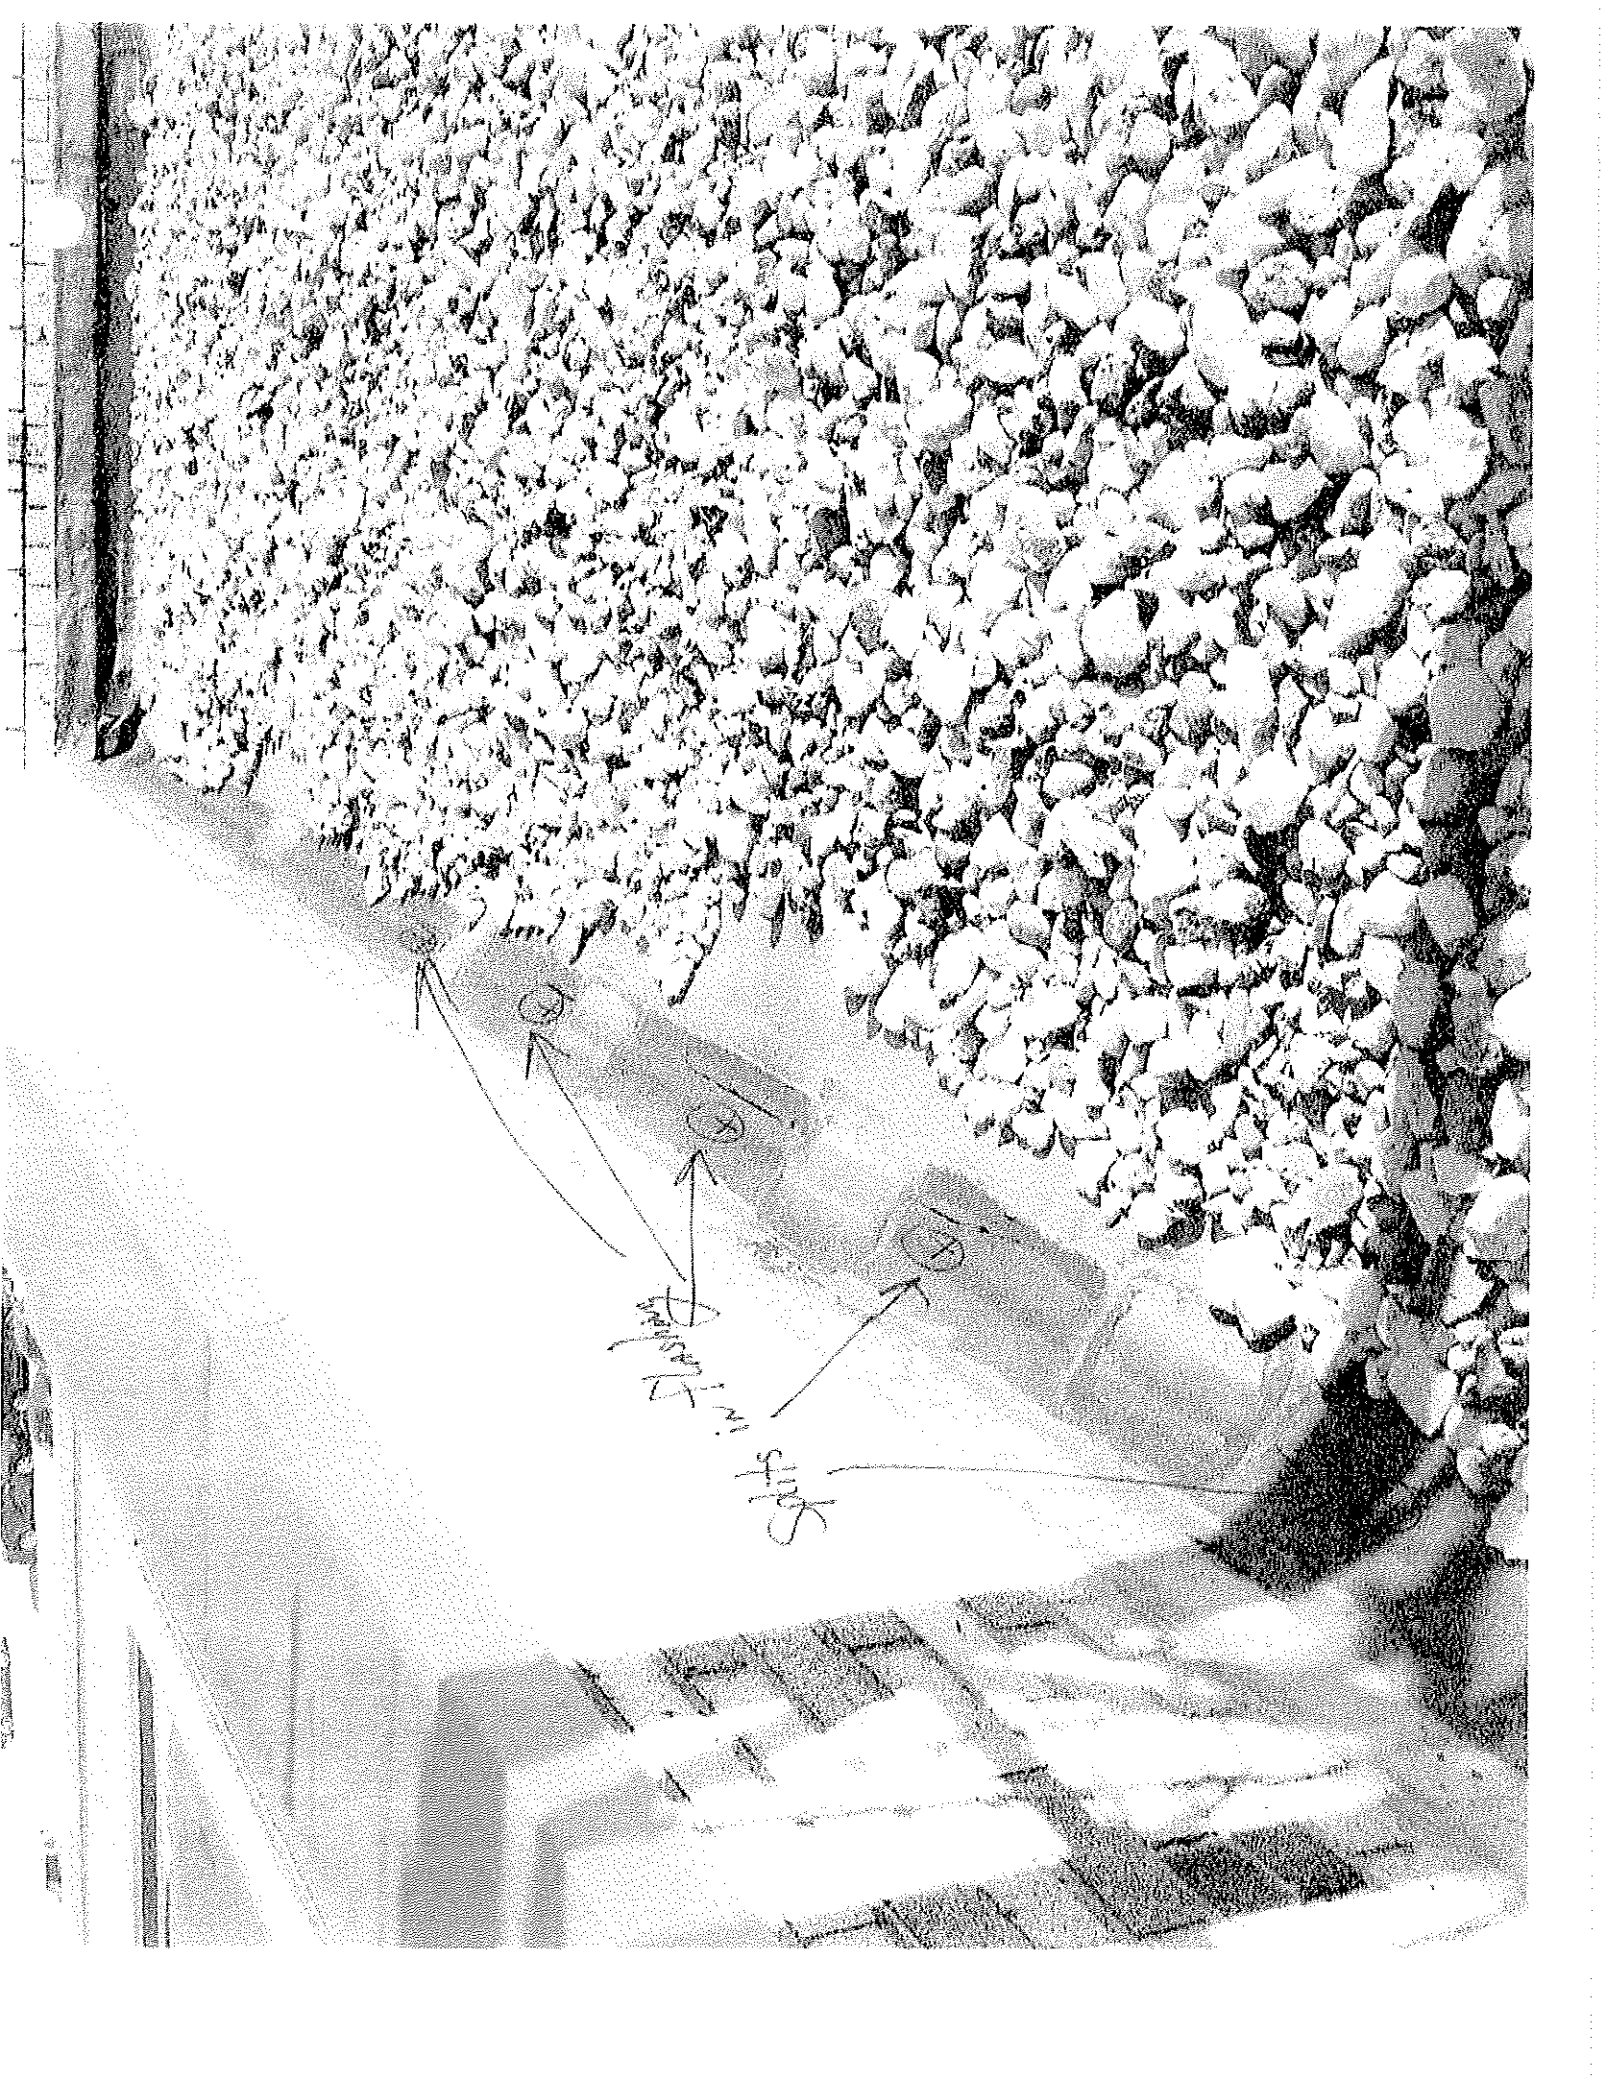
C-9.2

CAP FLASHING TERMINATION

We propose to remove the metal cap, extend new rubber 6" onto the roof, up the brick walls & over the top of the parapet walls & reinstall the metal cap. This will eliminate the following sources of leaks:

- ① The deteriorated rubber flashing
 - ② The counter-flashing with deteriorated caulk
 - ③ The brick joints
 - ④ The top of the walls where snow & ice pond
- After the rubber is extended up & over the walls, it will make it water-tight.

*We will install new Rubber membrane,
extend it up & over the parapet walls
& Reinstall the existing Cap.*

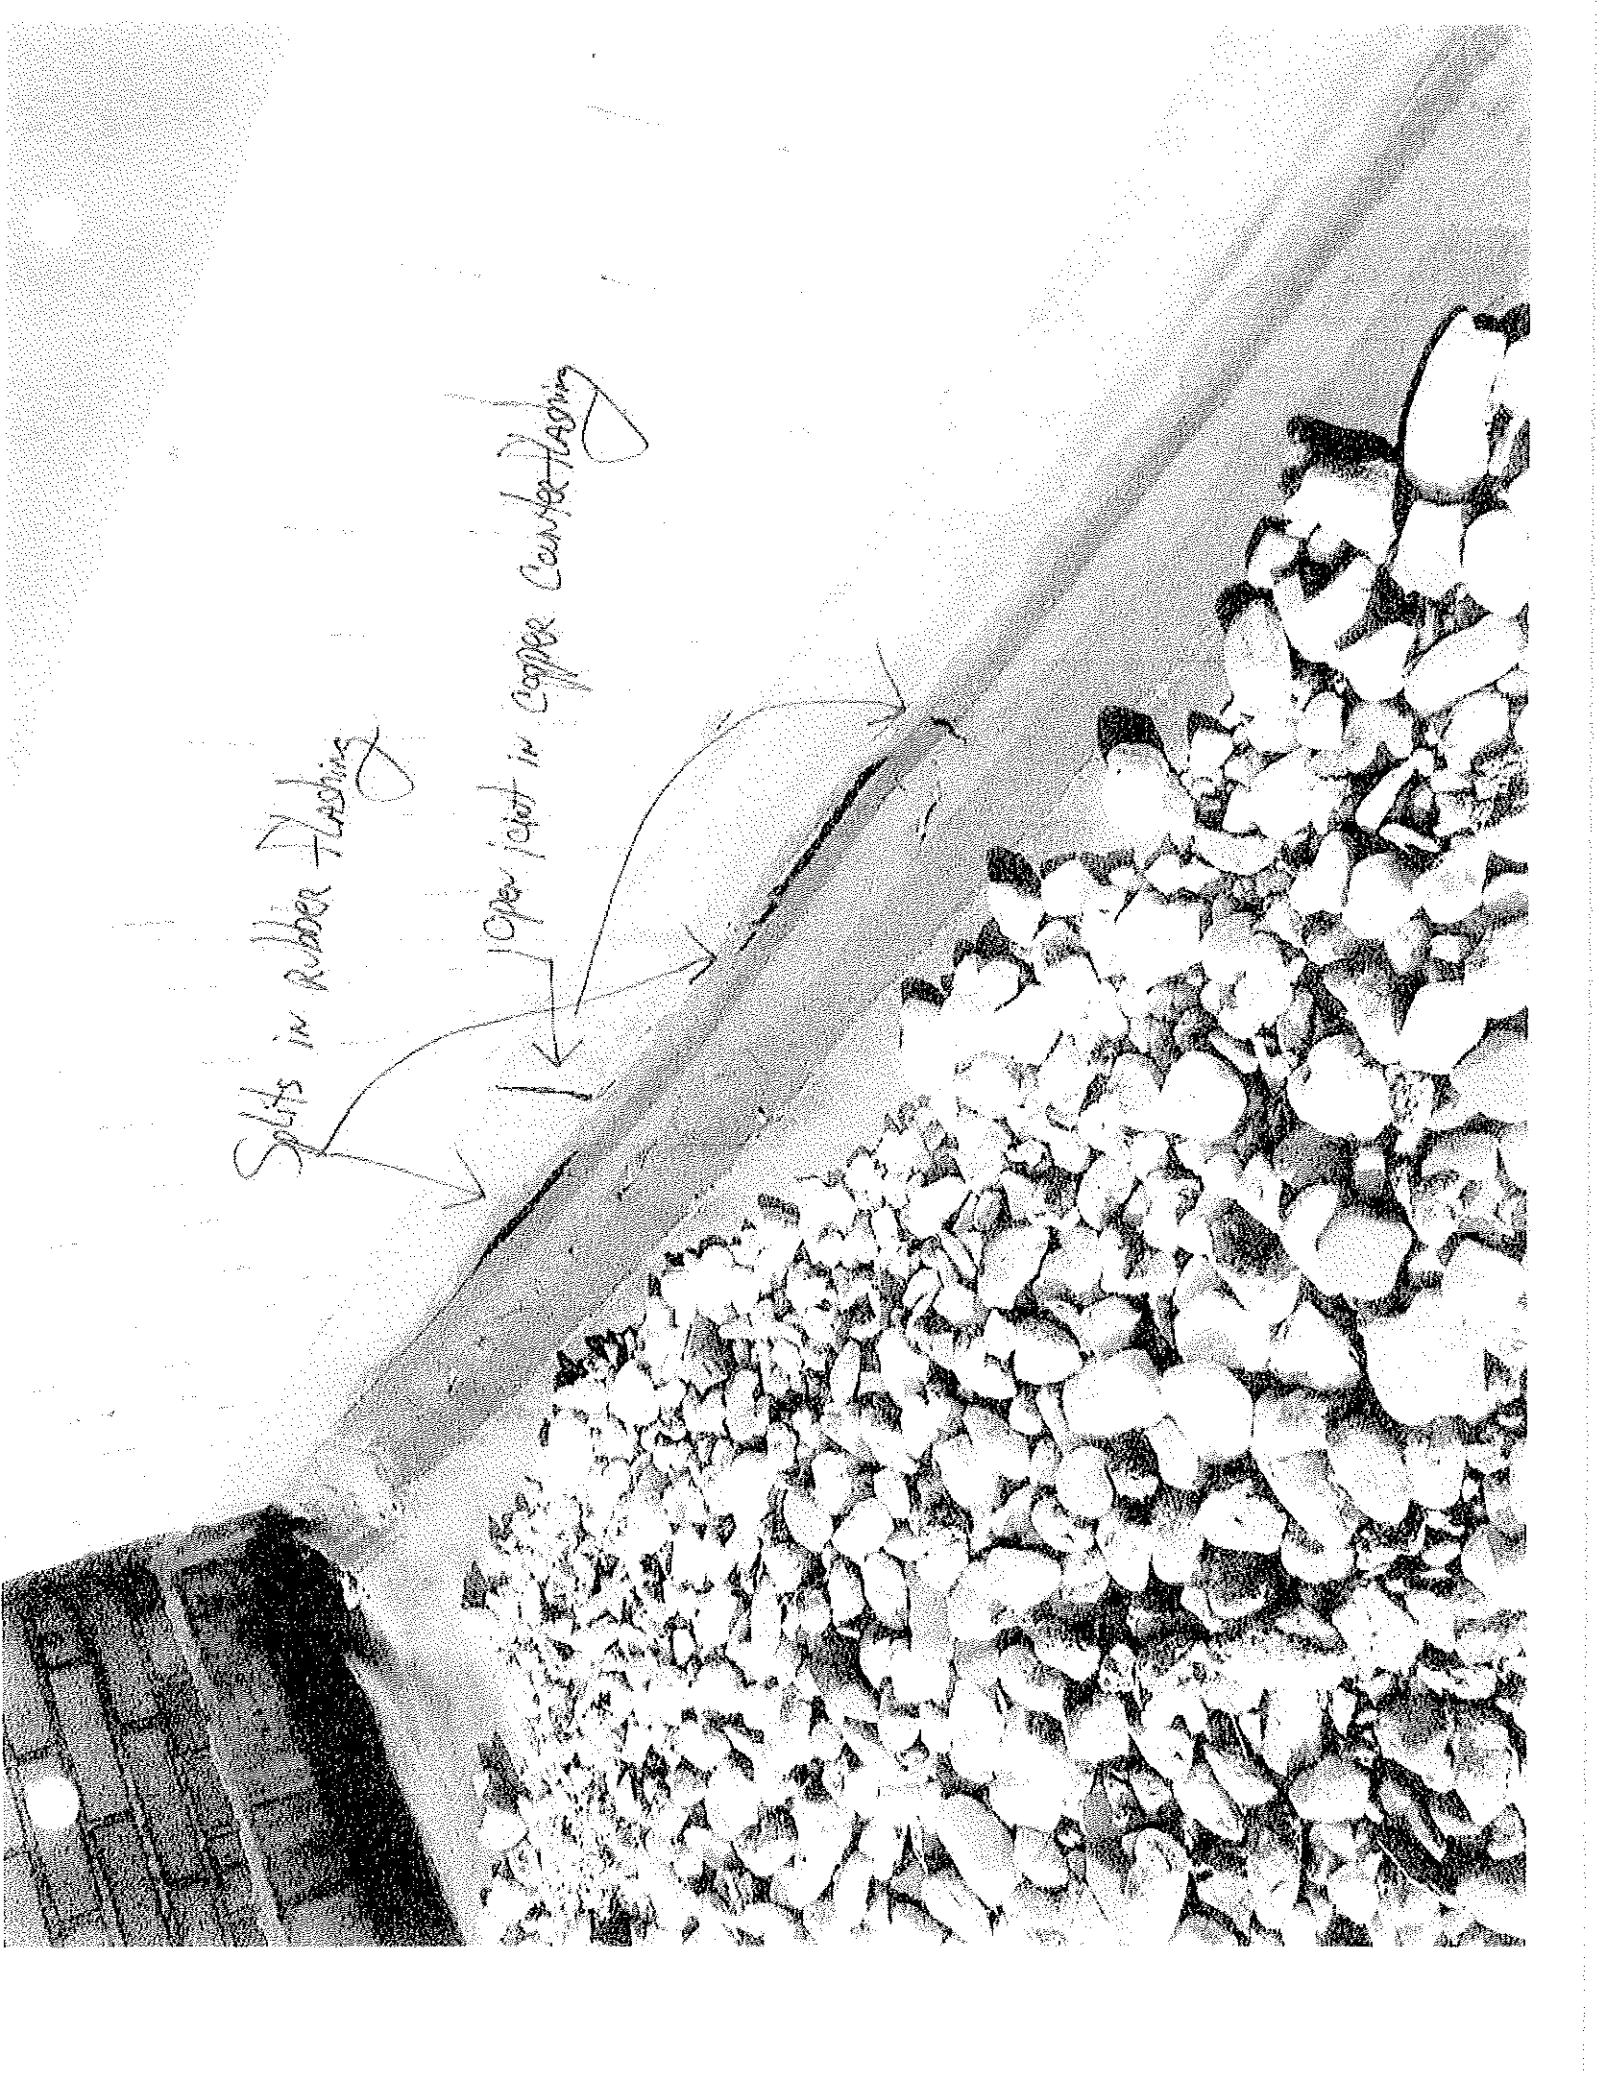
Open Joint in Copper Counter Flashing

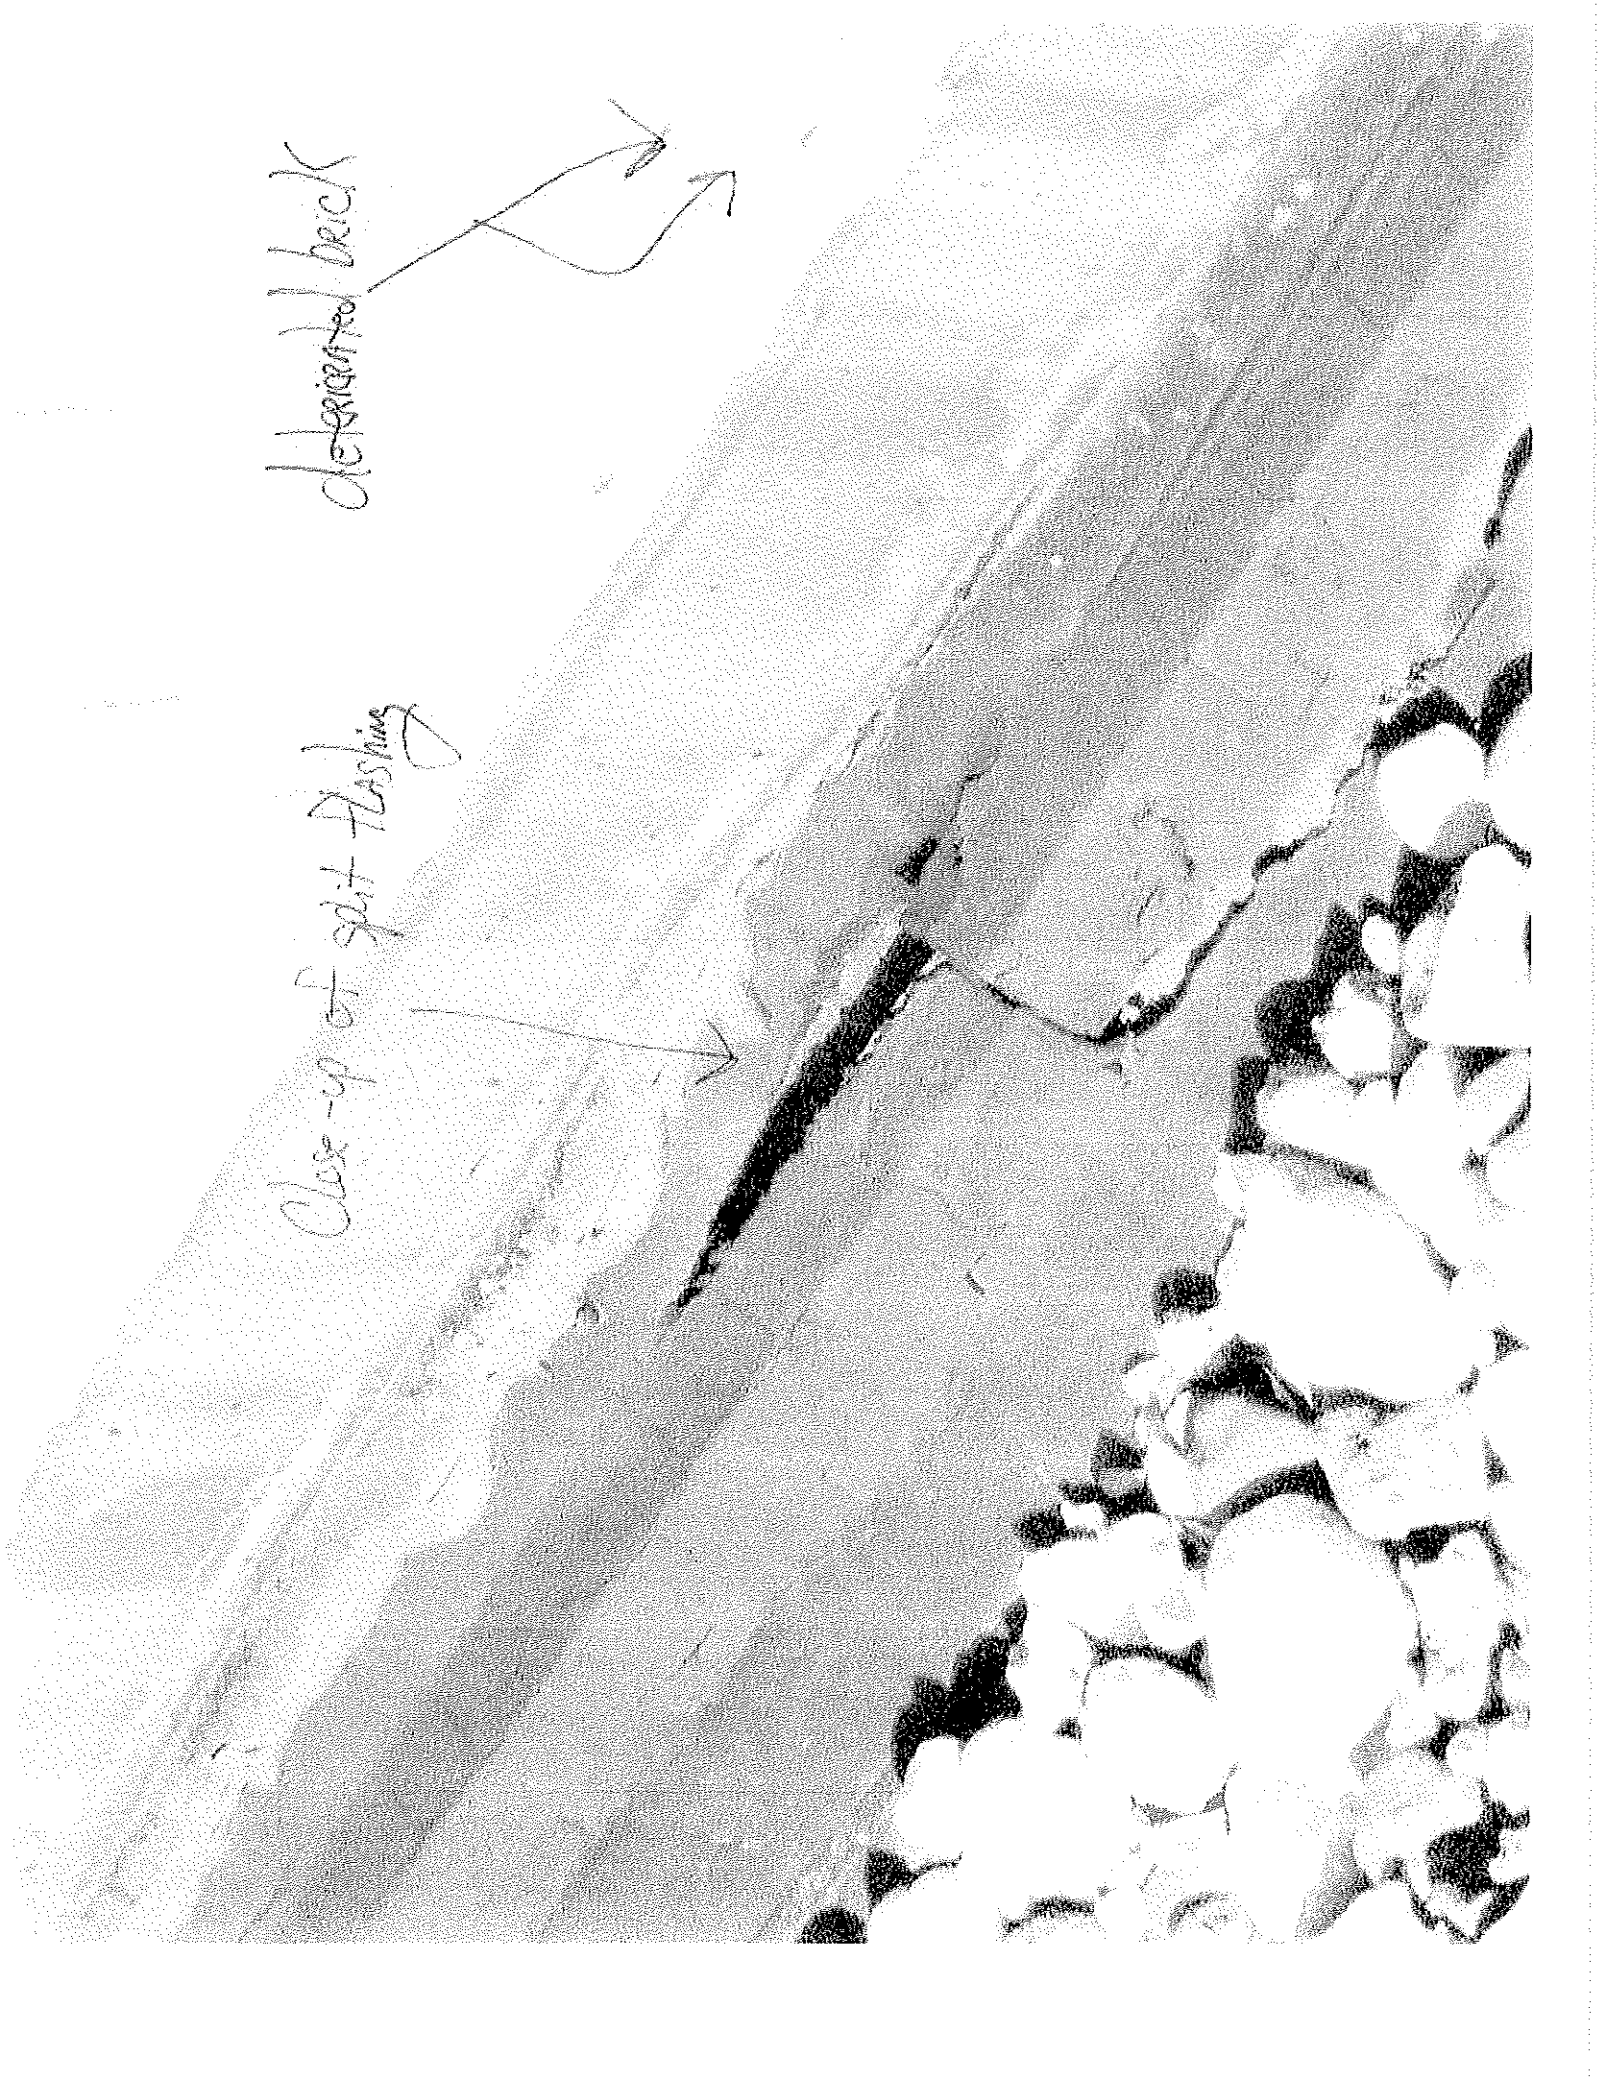
deteriorated brick

Close-up of spit-flashing

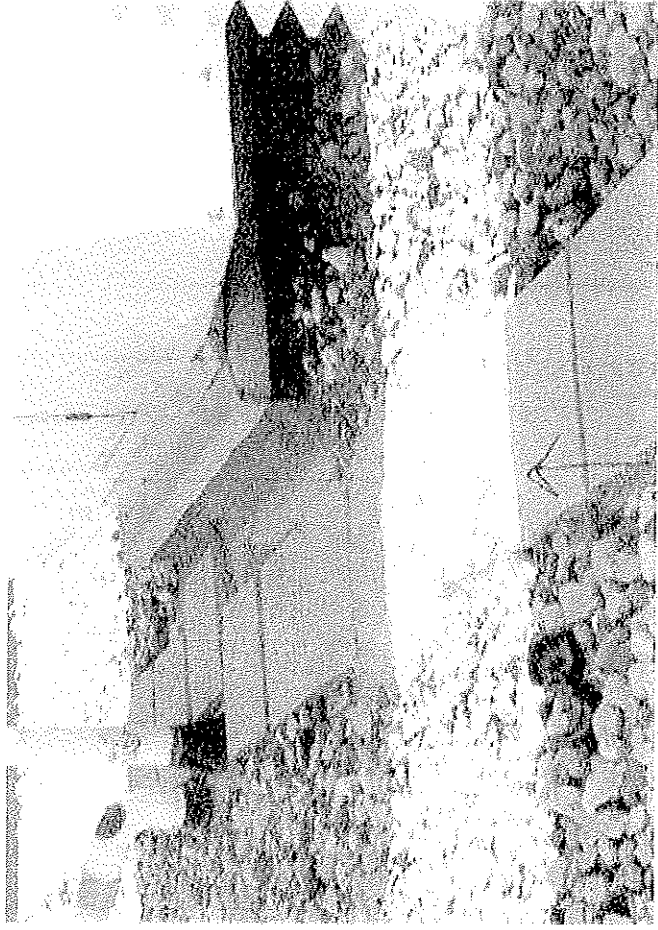
Bad Pavers

1. Remove the existing rubber flashing and properly dispose.
2. Remove the metal cap and reinstall upon completion of the following repairs.
3. Resecure the angle change as needed.
4. Scrub the area to insure a quality splice.
5. Apply weathered membrane cleaner.
6. Apply primer to prep the area.
7. Install 60 mil EPDM rubber flashing 6" onto the roof extending up and over the parapet walls .
8. Flash laps and corners.
9. Lap seal ends of the flashing as needed.
10. Replace the concrete pavers, not to exceed 20 pavers.

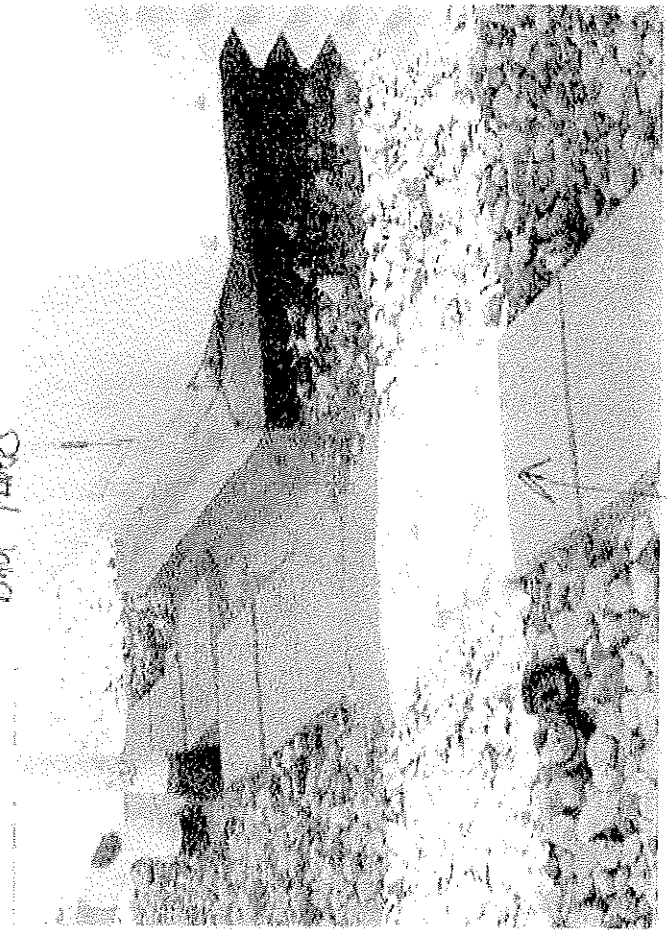
Bad Pavers

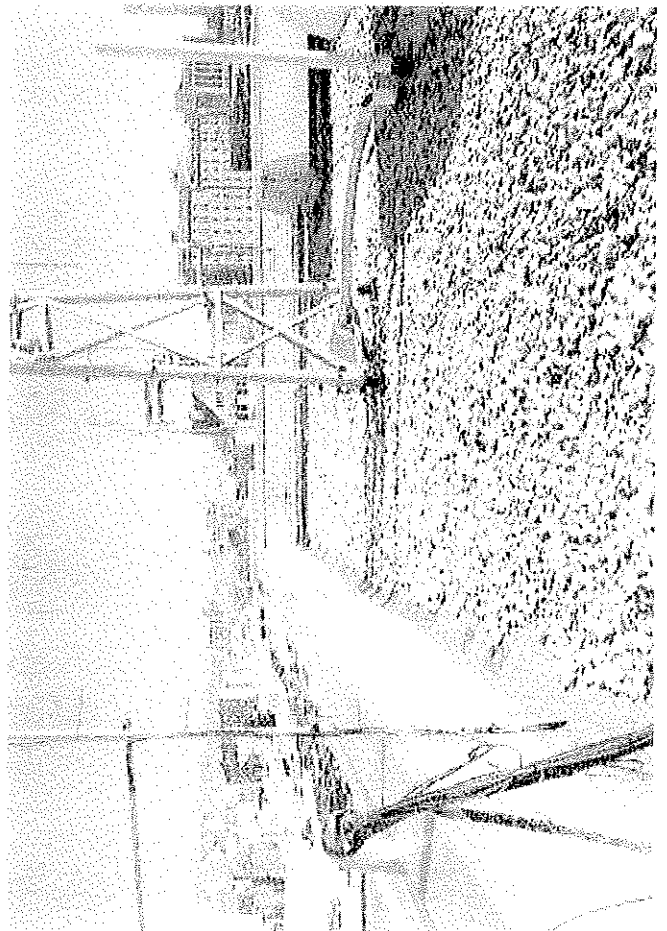
Deteriorated Brick

Split Flashing
