Park View Stormwater Drainage System Analysis

Figure 1
Park View Stormwater
Drainage System Analysis
Scott County, IA

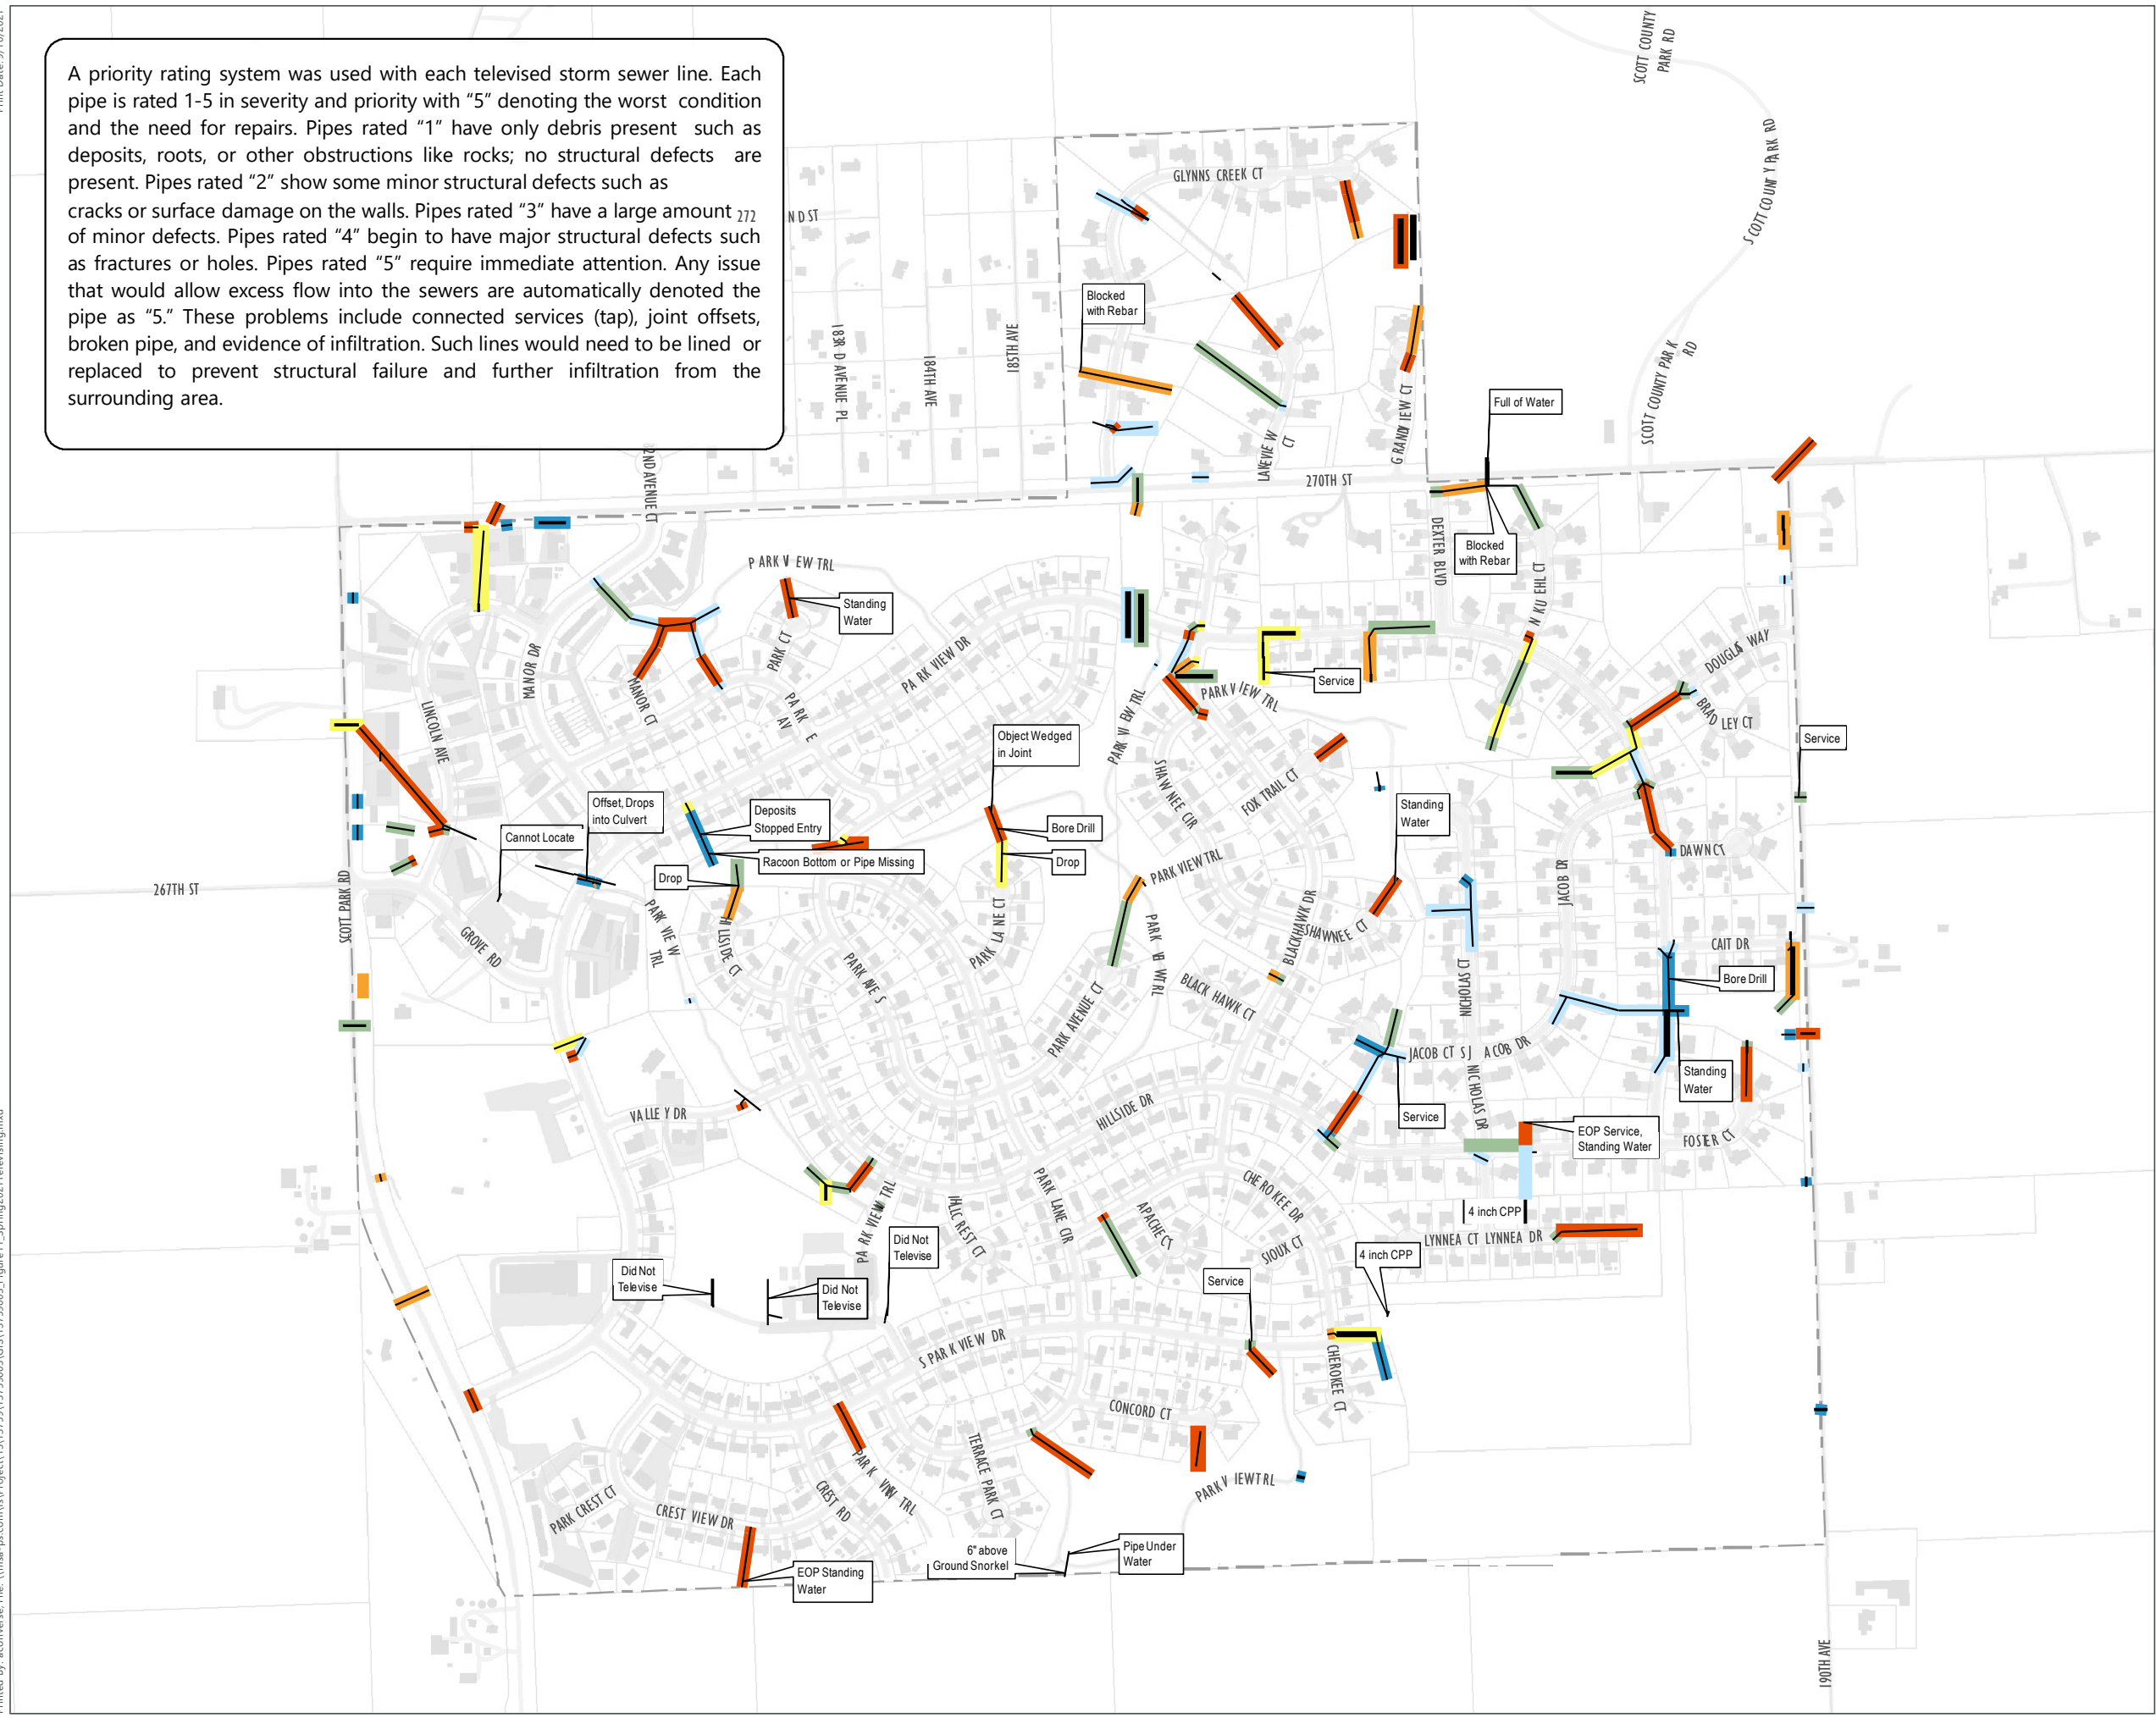
Figure 11
Park View Stormwater
Drainage System Analysis
Scott County, IA

A priority rating system was used with each televised storm sewer line. Each pipe is rated 1-5 in severity and priority with "5" denoting the worst condition and the need for repairs. Pipes rated "1" have only debris present such as deposits, roots, or other obstructions like rocks; no structural defects are present. Pipes rated "2" show some minor structural defects such as cracks or surface damage on the walls. Pipes rated "3" have a large amount of minor defects. Pipes rated "4" begin to have major structural defects such as fractures or holes. Pipes rated "5" require immediate attention. Any issue that would allow excess flow into the sewers are automatically denoted the pipe as "5." These problems include connected services (tap), joint offsets, broken pipe, and evidence of infiltration. Such lines would need to be lined or replaced to prevent structural failure and further infiltration from the surrounding area.

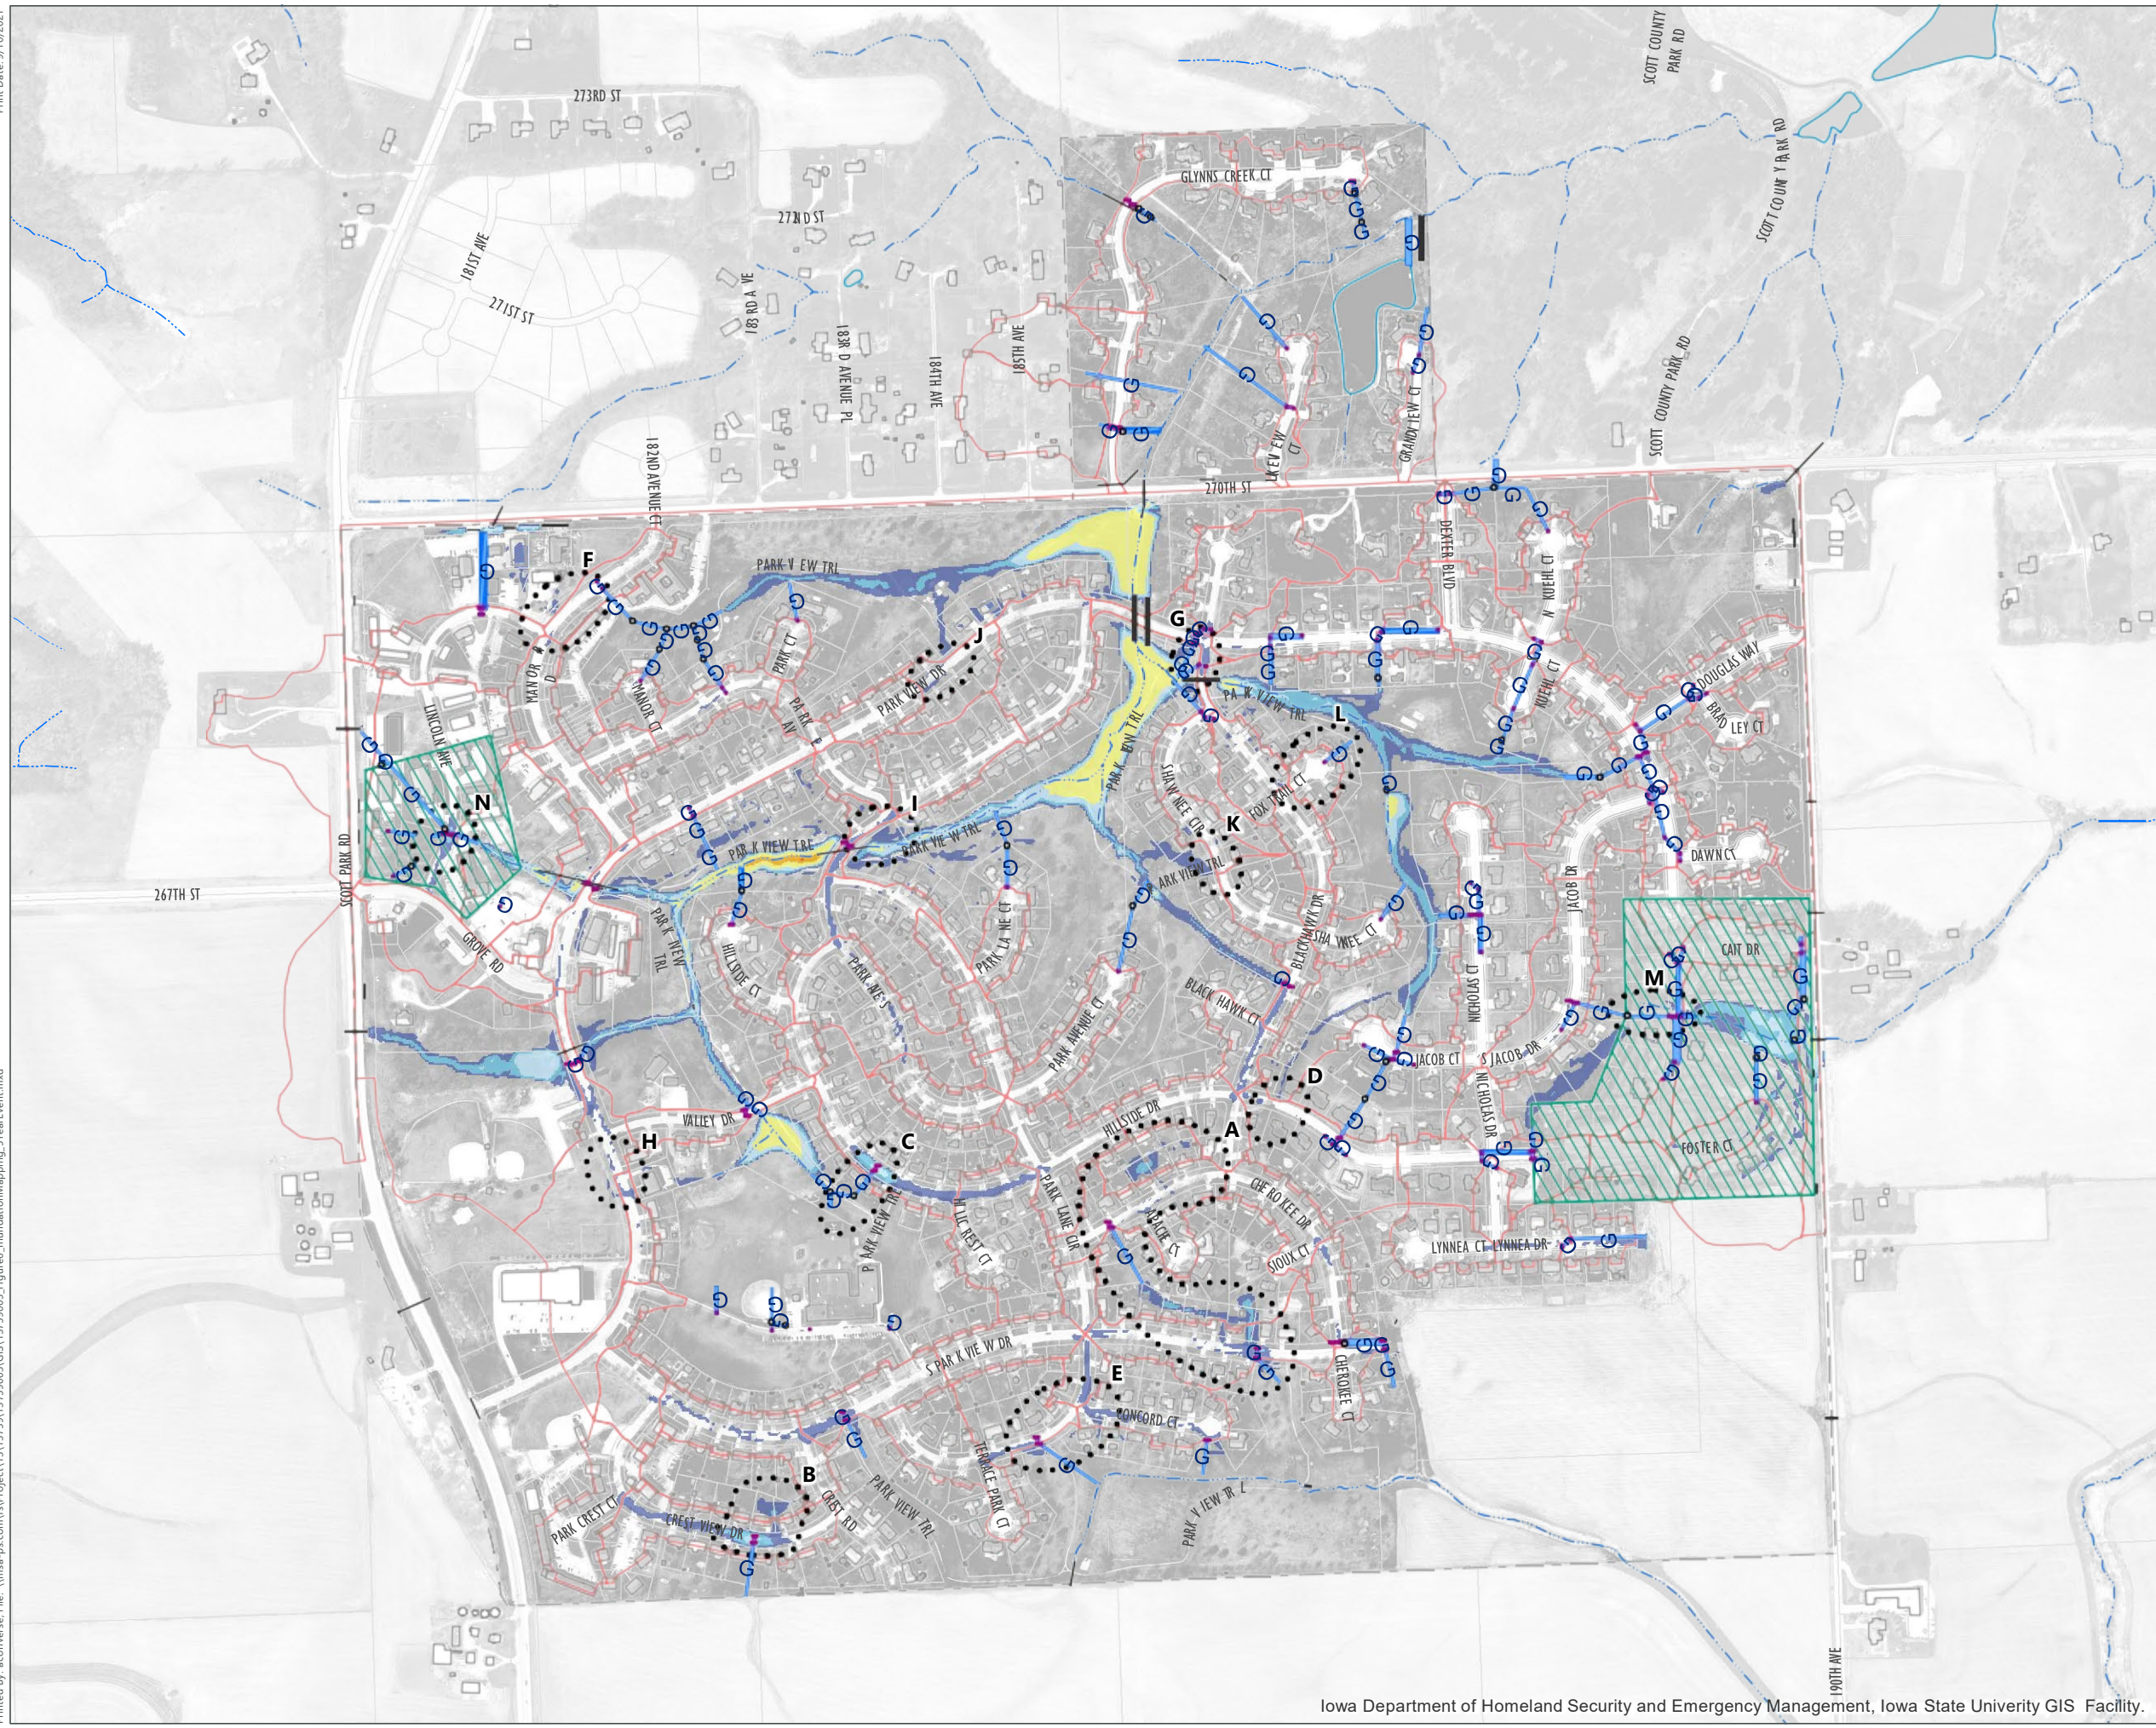
Figure 6
Park View Stormwater
Drainage System Analysis

Data Sources:
 Roads: Scott County
 Parcels: Scott County
 Stormwater System: MSA Survey
 *LiDAR Data used for flood modeling is older than recent development. Since surface grading affects overland flow patterns, updated elevation information is required. Flood modeling in these areas will be inaccurate.

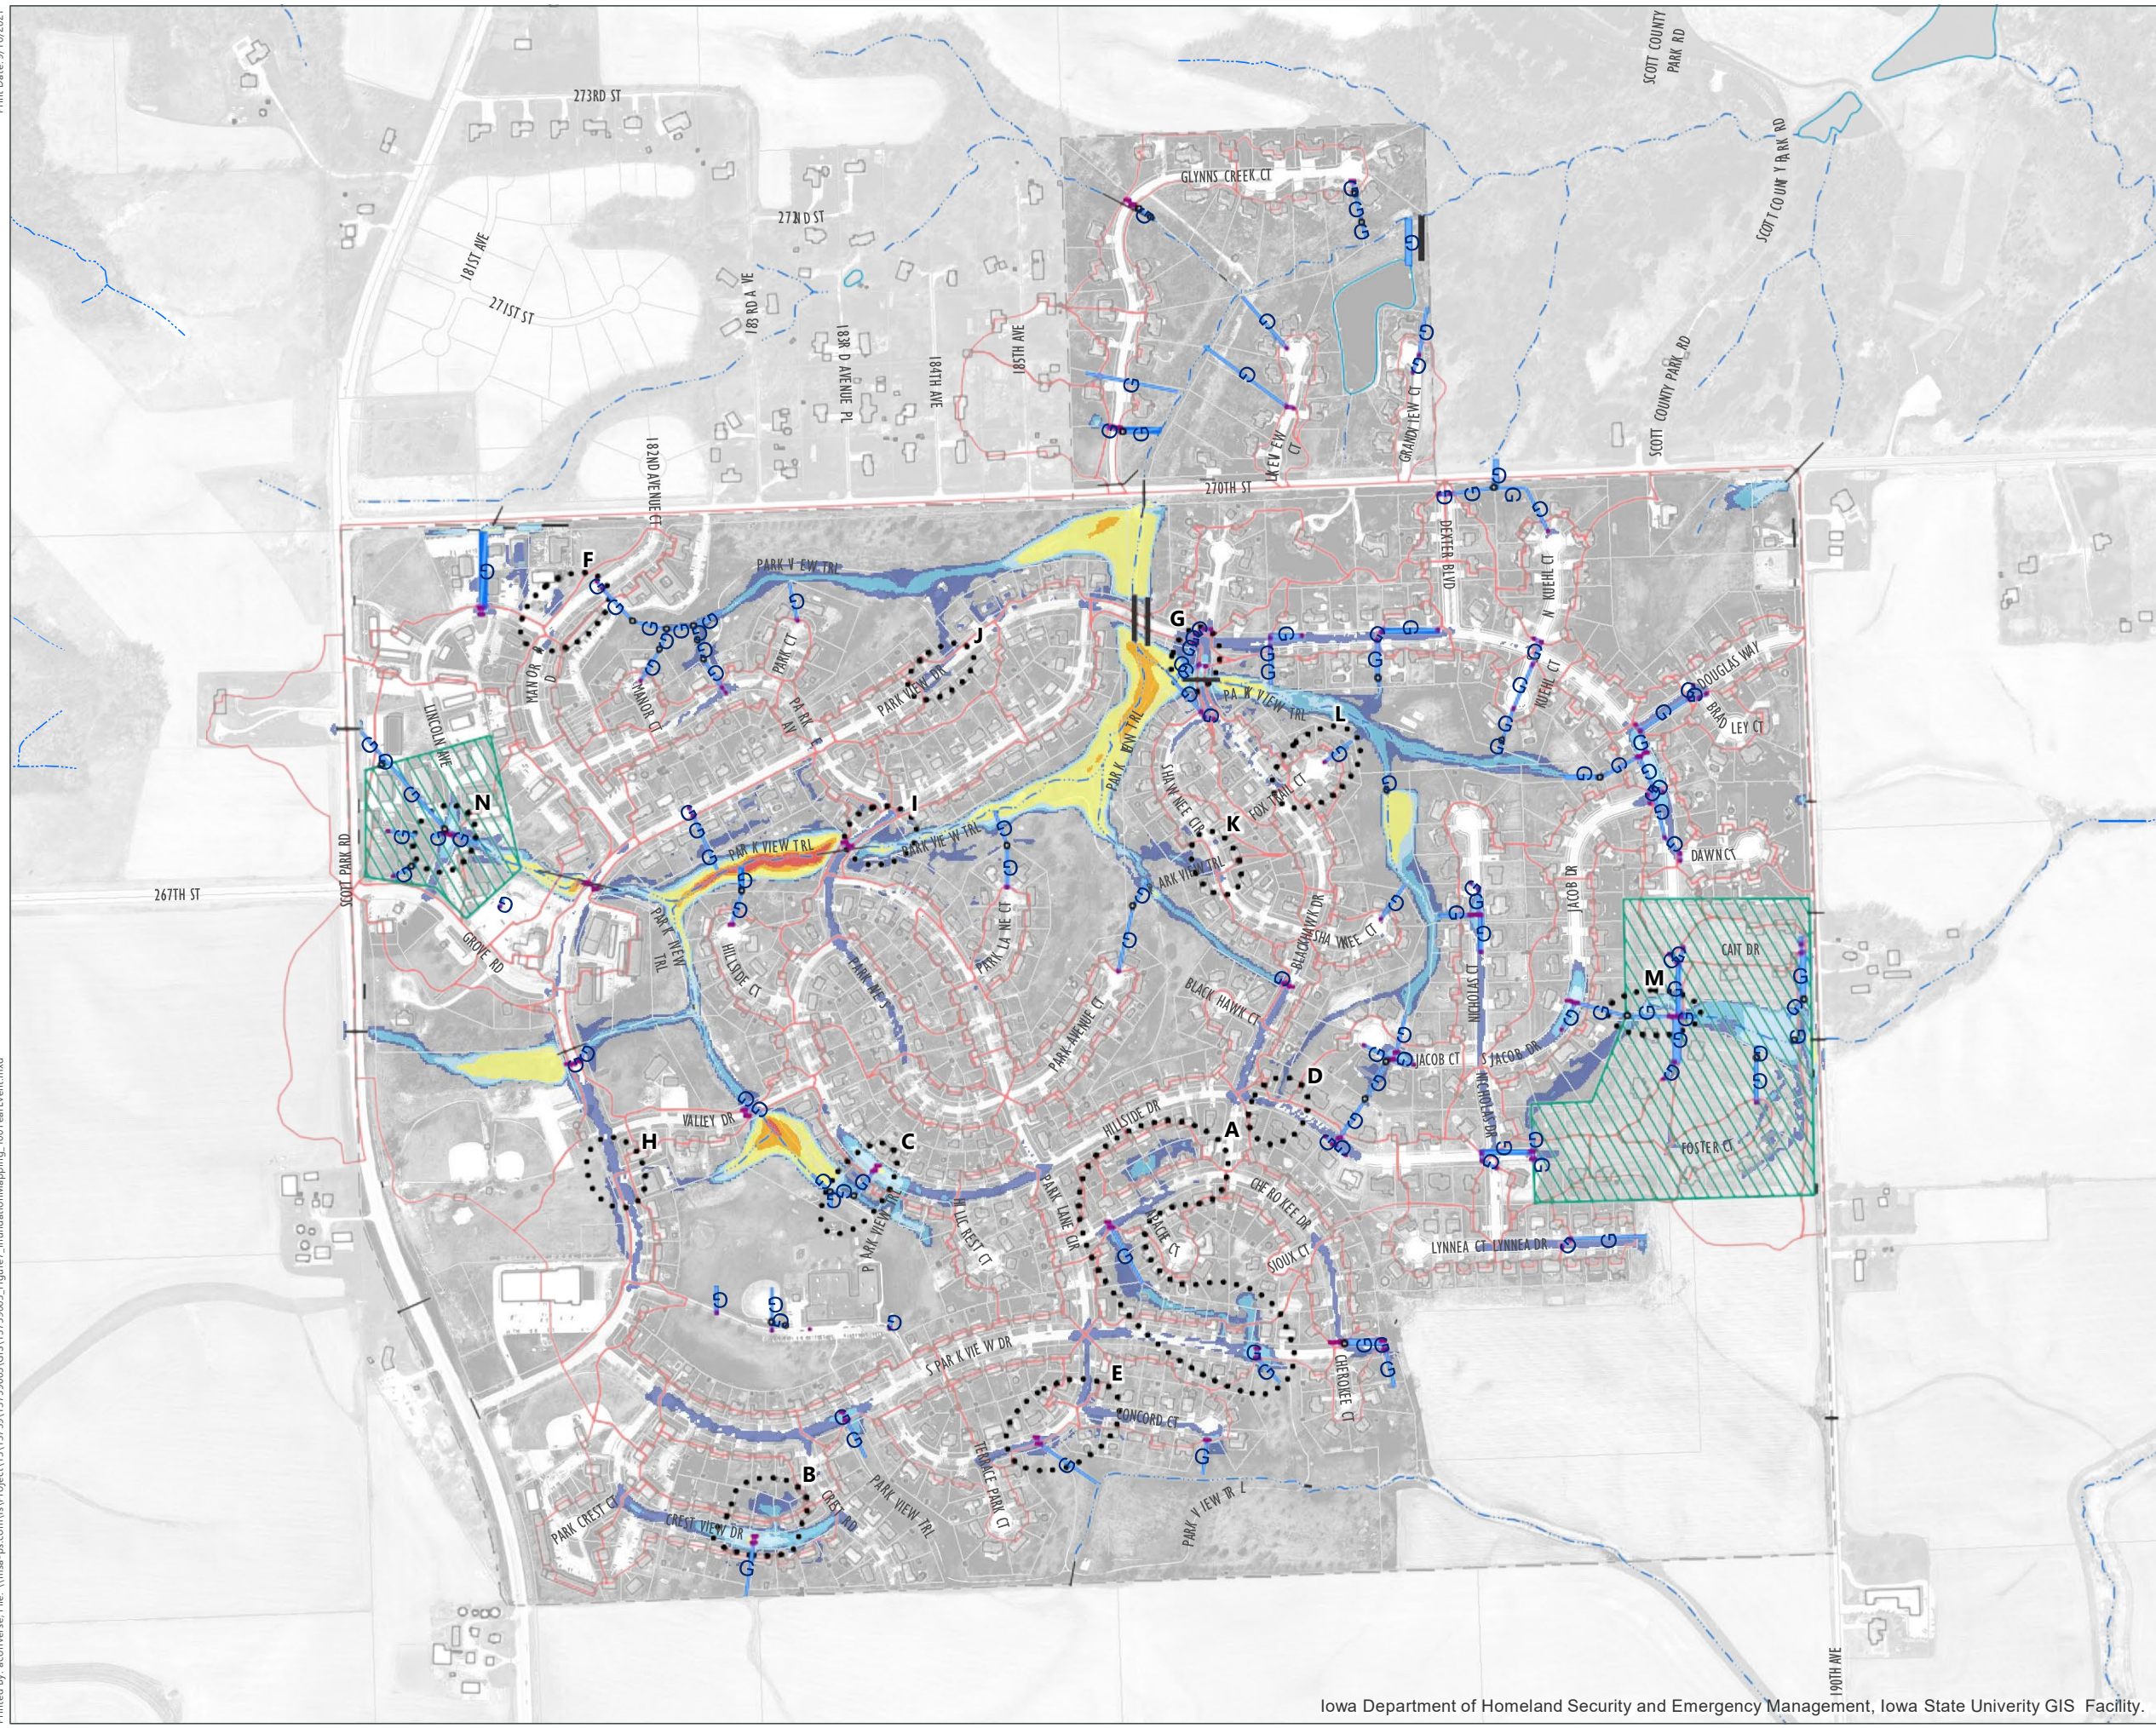
Figure 7
Park View Stormwater
Drainage System Analysis

Data Sources:
 Roads: Scott County
 Parcels: Scott County
 Stormwater System: MSA Survey
 *LiDAR Data used for flood modeling is older than recent development. Since surface grading affects overland flow patterns, updated elevation information is required. Flood modeling in these areas will be inaccurate.

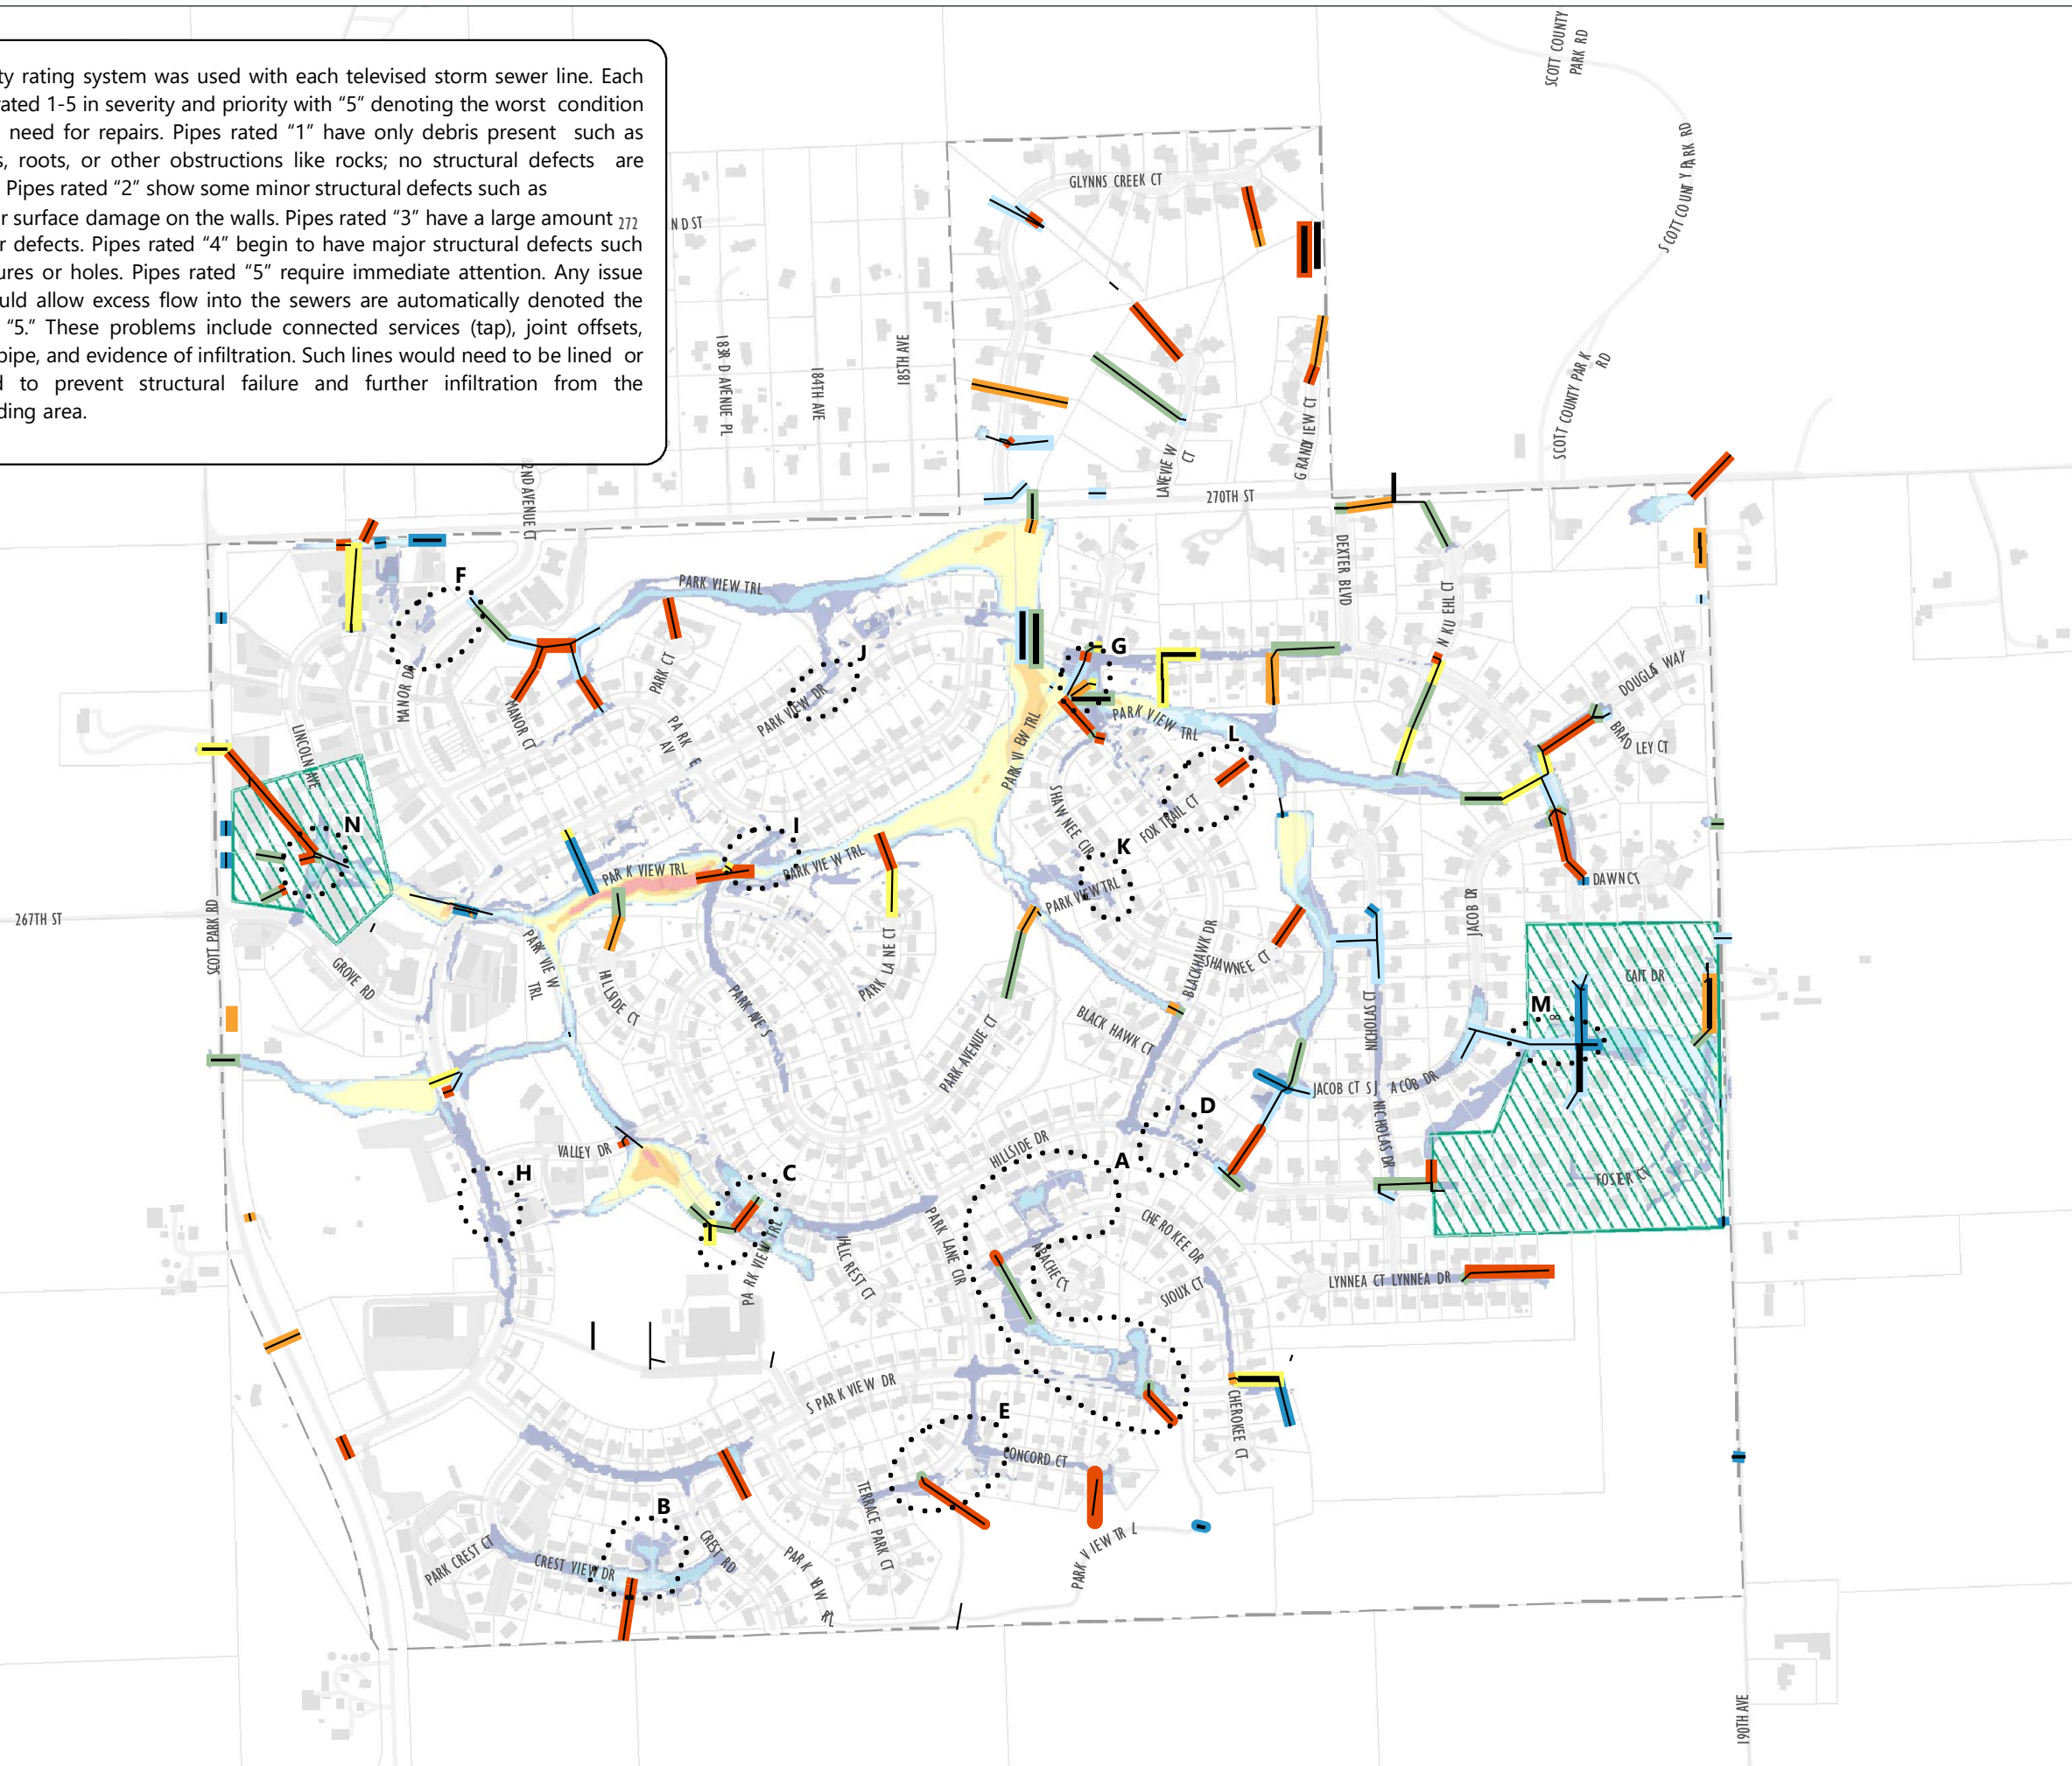
Figure 12
Park View Stormwater
Drainage System Analysis

A priority rating system was used with each televised storm sewer line. Each pipe is rated 1-5 in severity and priority with "5" denoting the worst condition and the need for repairs. Pipes rated "1" have only debris present such as deposits, roots, or other obstructions like rocks; no structural defects are present. Pipes rated "2" show some minor structural defects such as cracks or surface damage on the walls. Pipes rated "3" have a large amount of minor defects. Pipes rated "4" begin to have major structural defects such as fractures or holes. Pipes rated "5" require immediate attention. Any issue that would allow excess flow into the sewers are automatically denoted the pipe as "5." These problems include connected services (tap), joint offsets, broken pipe, and evidence of infiltration. Such lines would need to be lined or replaced to prevent structural failure and further infiltration from the surrounding area.
