Facility and Support Services

Subj: Repairs to the Courthouse roof

After we made recent repairs to the roof on the Court House, Craig Jones inspected the two smaller upper level roofs. We have included several digital photos to show the problems. The following items can cause leaks on these perimeter walls:

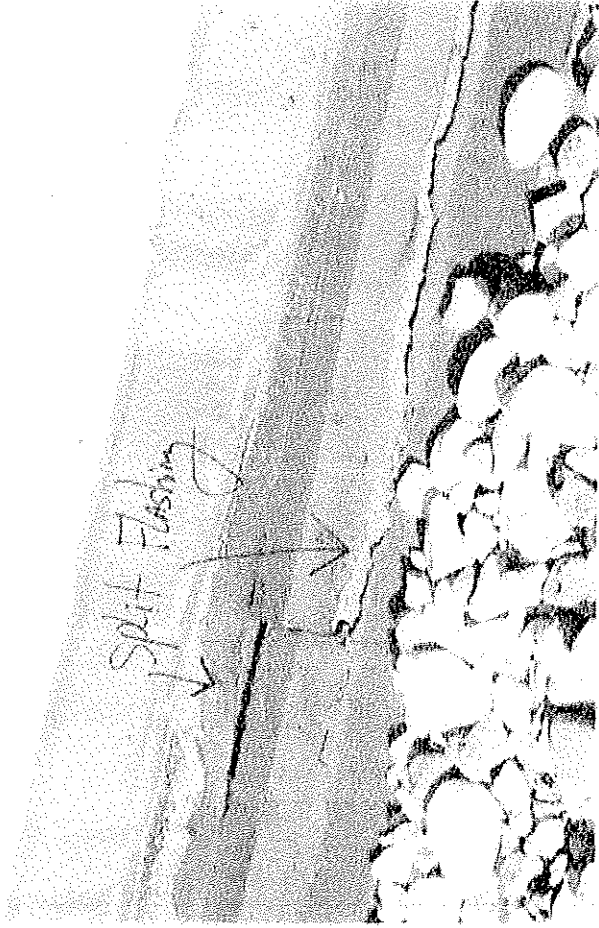
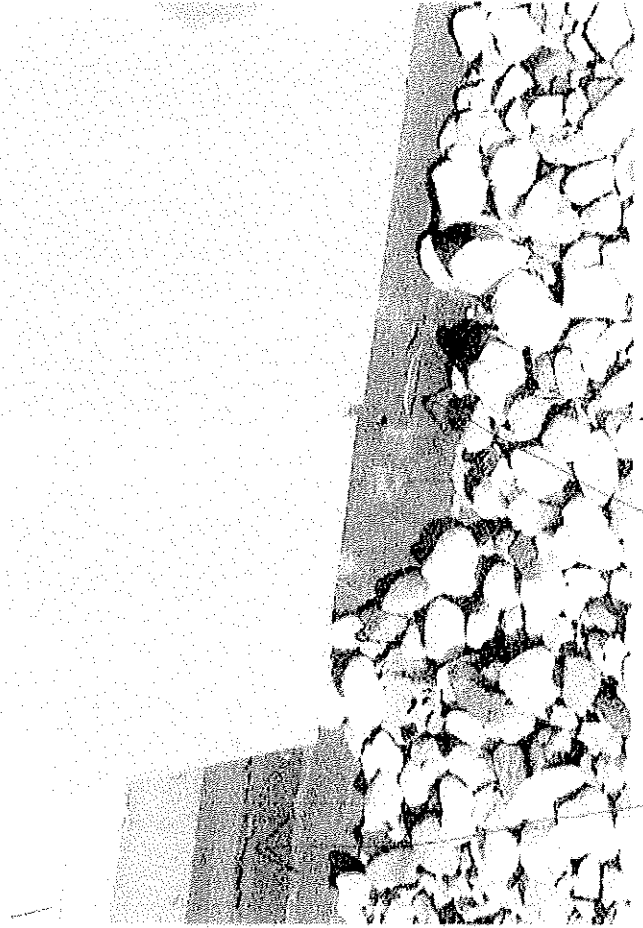
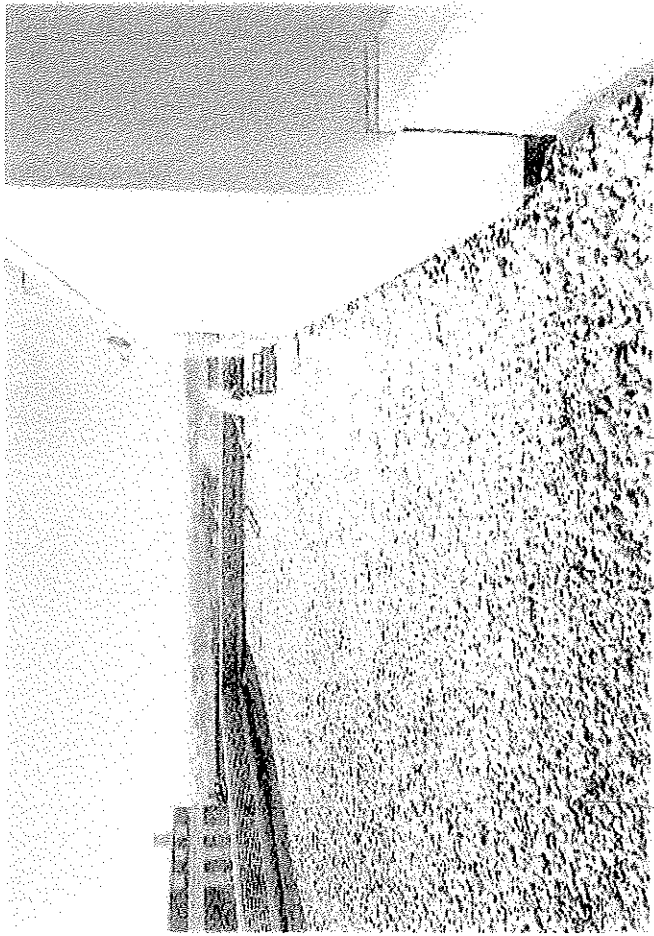
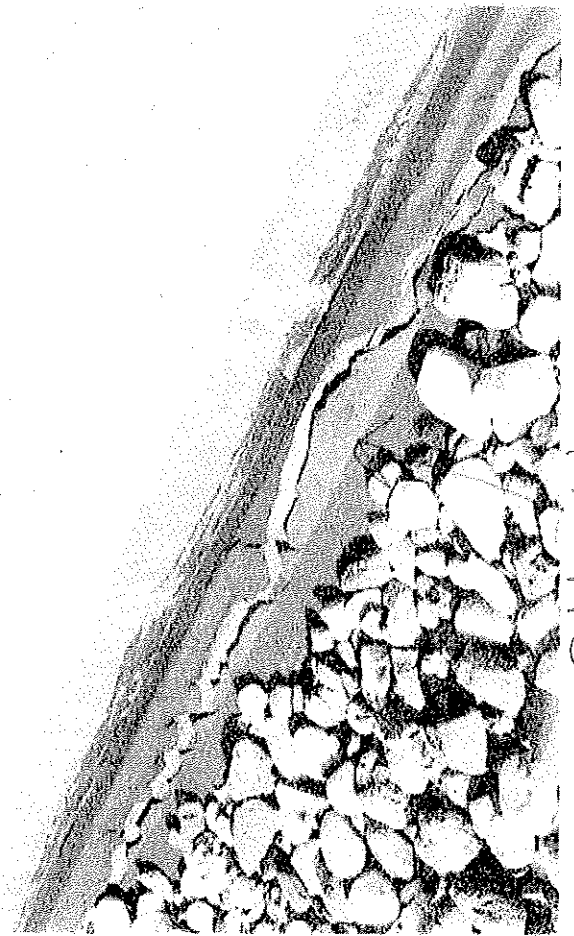
- A. The perimeter rubber flashing is severely deteriorated.
- B. The counter flashing caulk has cracks and splits.
- C. The face on some of the bricks is splitting.
- D. The metal cap on top of the parapet walls ponds water.

We propose to remove the metal cap, extend new rubber 6" onto the roof, up the brick walls & over the top of the parapet walls & reinstall the metal cap. This will eliminate the following sources of leaks:

- ① The deteriorated rubber flashing
 - ② The counter-flashing with deteriorated caulk
 - ③ The brick joints
 - ④ The top of the walls where snow & ice pond
- After the rubber is extended up & over the walls, it will make it water-tight.

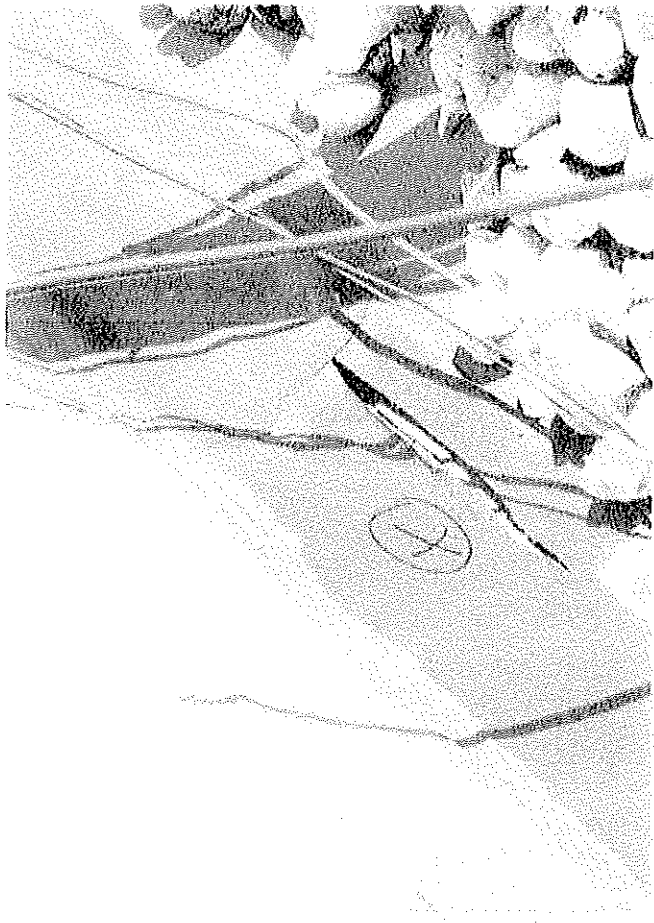
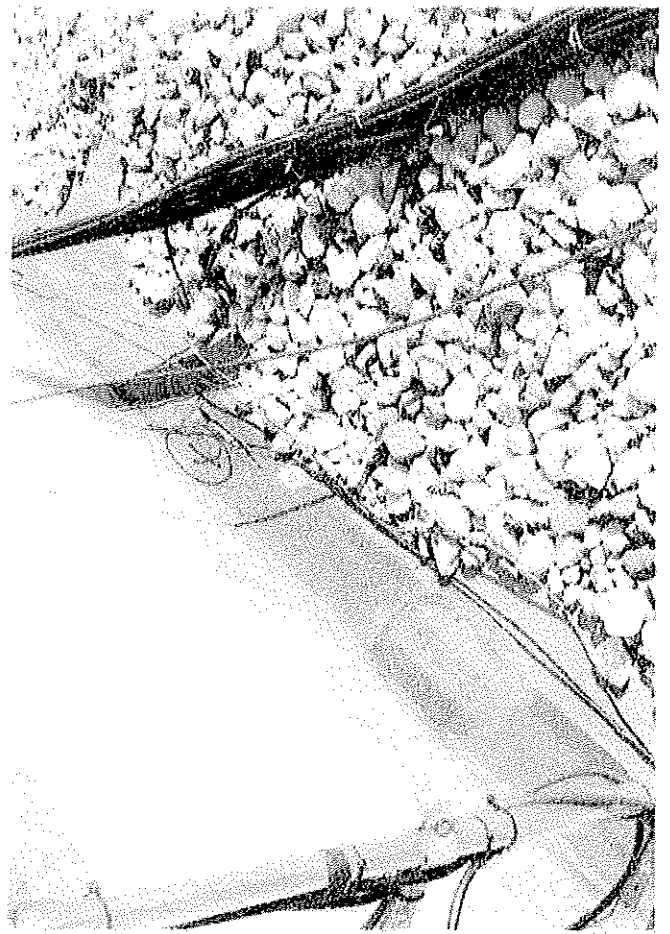
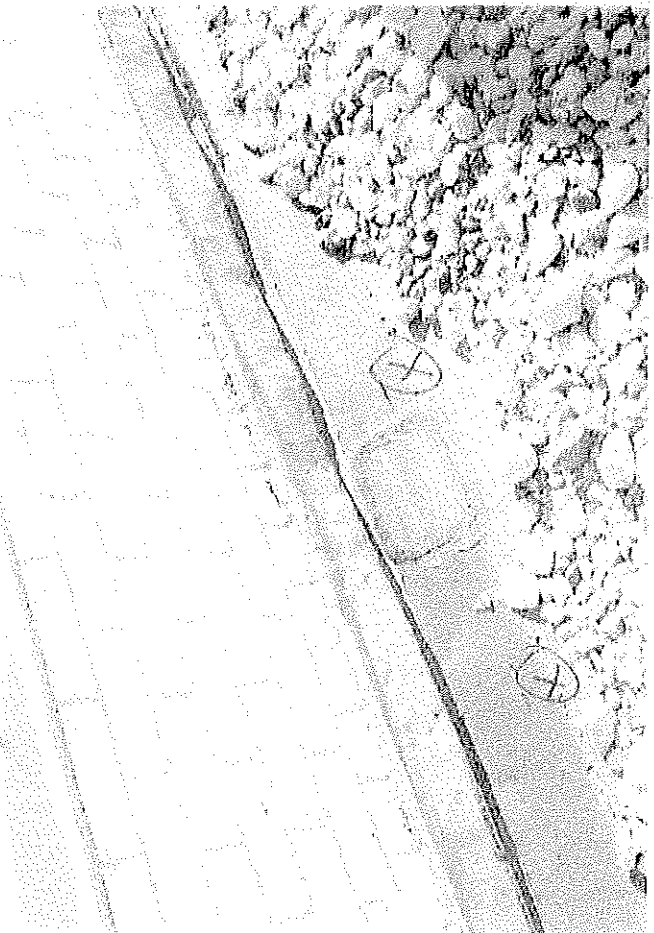
Splits in Rubber Flashing

Open Joint in Copper Counter Flashing
